REMEDIAL INVESTIGATION REPORT FOR OPERABLE UNIT 2: POTENTIAL ON-SITE CONTAMINANT SOURCE AREAS

NATIONAL AERONAUTICS AND SPACE ADMINISTRATION

JET PROPULSION LABORATORY

November, 1999

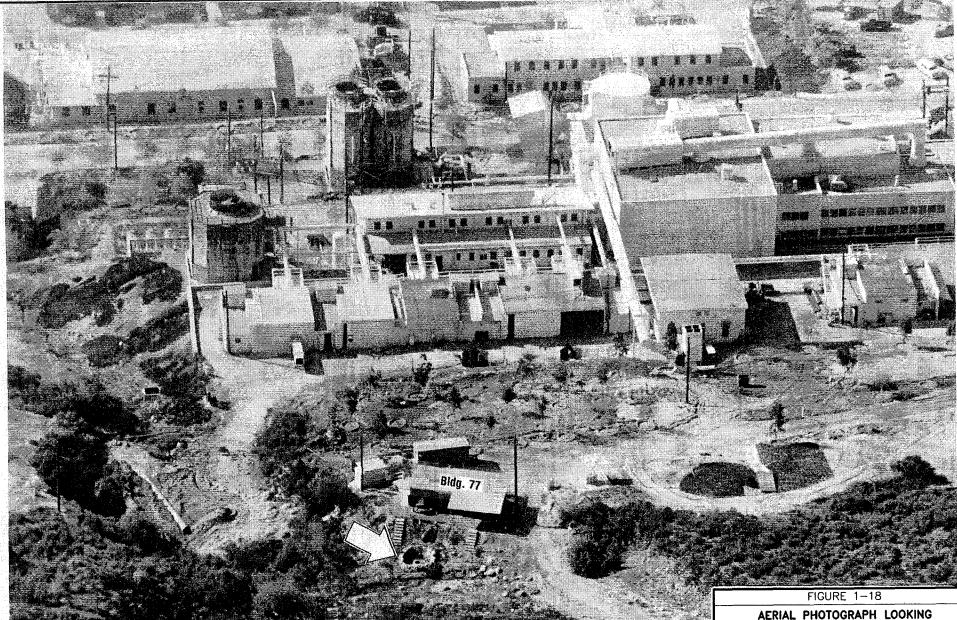
Notice pit inside mortared—rubble wall at bottom of photo; identified as Pit 3 in PA and SI reports. (Aerial Photo No. JB 1110Z from JPL Photo Library)

AERIAL PHOTOGRAPH LOOKING SOUTH AT PART OF JPL Photo Date: Unknown
